Woodridge  
**PARK DISTRICT**  
WOODRIDGE, ILLINOIS

# ADA TRANSITION PLAN

PLAN UPDATES APPROVED BY BOARD OF COMMISSIONERS  
JULY 20, 2021

FACILITY/SITE EVALUATION COMPLETED BY: MARK TRIEGLAFF  
ACCESSIBILITY CONSULTATION AND TRAINING SERVICES  
(630) 303-3677 | [MTRIEGLAFF@SBCGLOBAL.NET](mailto:MTRIEGLAFF@SBCGLOBAL.NET)

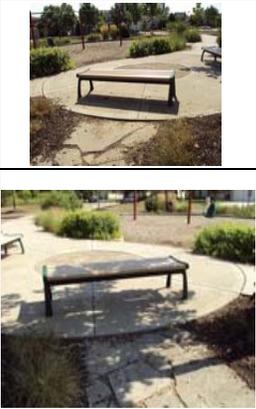
Item #	Photo	Barrier	ADAAG/IAC	Solution	Priority	By Whom	Projected Cost	Projected Date	Action Taken
WM.14

<p>340</p>	Two benches are provided to the west of the swings but they do not provide backs or armrests.	Propose Outdoor Developed Areas Guidelines 16.12 & New Proposed ADAAG 903.2, 903.4 and 903.5	<b>Bench Recommendation:</b> Provide at least 50% but no less than one bench to have a maximum gap of 2 1/2" from the back support to the rear edge of the seat. Also have the seat height between 17" to 19" AFF. (See Proposed New ADAAG Figure 903.4 Bench Back Support). Provide a clear floor space of a minimum of 48" by a minimum of 30" at one end. And a minimum of one armrest at the accessible bench. Provide an accessible bench (\$700) on the concrete surface and along the accessible route.	2	Park District	\$ 700.00	2020-2024	
WM.15
