Woodridge  
**PARK DISTRICT**  
WOODRIDGE, ILLINOIS

# ADA TRANSITION PLAN

PLAN UPDATES APPROVED BY BOARD OF COMMISSIONERS  
JULY 20, 2021

FACILITY/SITE EVALUATION COMPLETED BY: MARK TRIEGLAFF  
ACCESSIBILITY CONSULTATION AND TRAINING SERVICES  
(630) 303-3677 | [MTRIEGLAFF@SBCGLOBAL.NET](mailto:MTRIEGLAFF@SBCGLOBAL.NET)

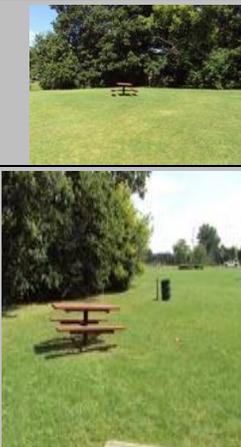
Two picnic tables are provided that are located in the grass and do not provide the 27" knee clearance.	Proposed Outdoor Developed Areas Guidelines 16.5	<b>Picnic Table Recommendation:</b> Follow Outdoor Developed Area Report that states 50% of picnic tables, but no less than one, be of accessible design, and 40% of accessible design tables be connected to an accessible route. Relocate or purchase an accessible picnic table (\$750) and locate it on an accessible surface (\$900). Tie the accessible picnic table into the new accessible route from the parking lot.	C	Park District	\$ 1,650.00	2011	2 accessible picnic tables provided along an accessible route developed w/ 2011 site improvements.
FP.9

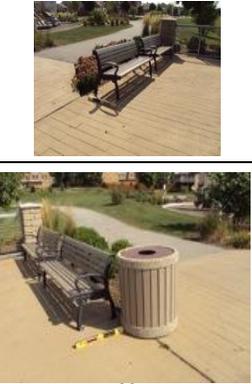
Four benches are provided but located on a very sloped surface with the running slope for companion seating between 5.1% to 5.2%.	Propose Outdoor Developed Areas Guidelines 16.12 & New Proposed ADAAG 903.2, 903.4 and 903.5	<b>Bench Recommendation:</b> Provide at least 50% of the benches to have a maximum gap of 2 1/2" from the back support to the rear edge of the seat. Also have the seat height between 17" to 19" AFF. Provide a clear floor space of a minimum of 48" by a minimum of 30" at one end. And a minimum of one armrest at the accessible bench. Relocated two benches to a surface no steeper than 2% in all directions or purchase three benches and locate them on an accessible surface.	2	Park District	\$ 1,000.00	2031-2035
