Woodridge
PARK DISTRICT

JUBILEE POINT PARK

NATURAL AREA IMPROVEMENT PLAN

DRAFT

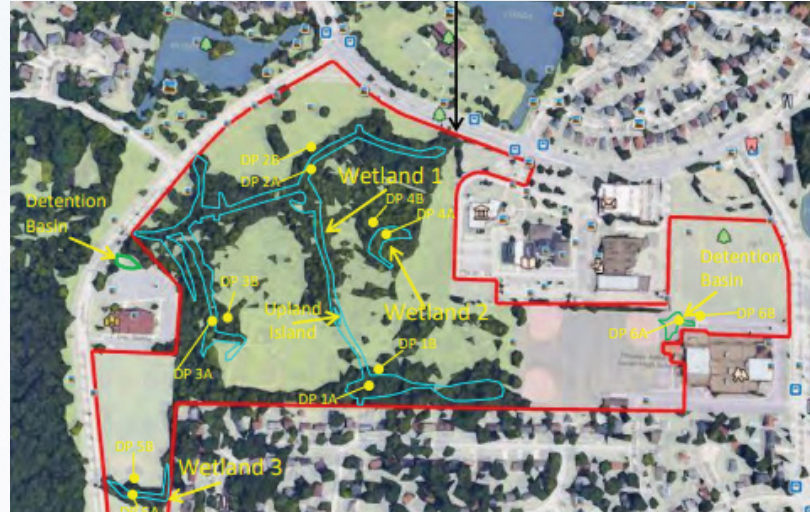
FIGURE 3 - 2018 WETLAND DELINEATION MAP

Two wetland delineations have been conducted on the site. The first delineation took place in 2018. During the study, three wetlands were identified on the site which can be seen to the right in **Figure 3**.

Wetland 1 is an emergent and scrub/shrub wetland with a Native Mean C-value of 2.19 indicative of a wetland plant community and low floristic quality. Along with this, positive wetland hydrology was indicated because of the presence of a high-water table, saturation and positive FAC-neutral test. This wetland contains Ashkum silty clay loam.

Wetland 2 is a forested and scrub/shrub wetland. This wetland also has characteristics of a wetland plant community and low floristic quality due to the Native Mean C-value being 1.53, as well as a positive wetland hydrology was indicated because of the presence of a high-water table, saturation and positive FAC-neutral test. The soil type that makes up this wetland is Ozaukee silt loam, 2 to 4%.

Wetland 3 is an emergent and scrub-shrub wetland with a creek channel at its center flowing from east to west. It was found that this wetland has a Native Mean C-Value of 1.5 indicative of a wetland plant community of low floristic quality. A positive wetland hydrology was recorded due to the presence of a high-water table, saturation, drift deposits, exposed/buttrressing roots, and drainage patterns. Soils were mapped as Ashkum silty clay loam.

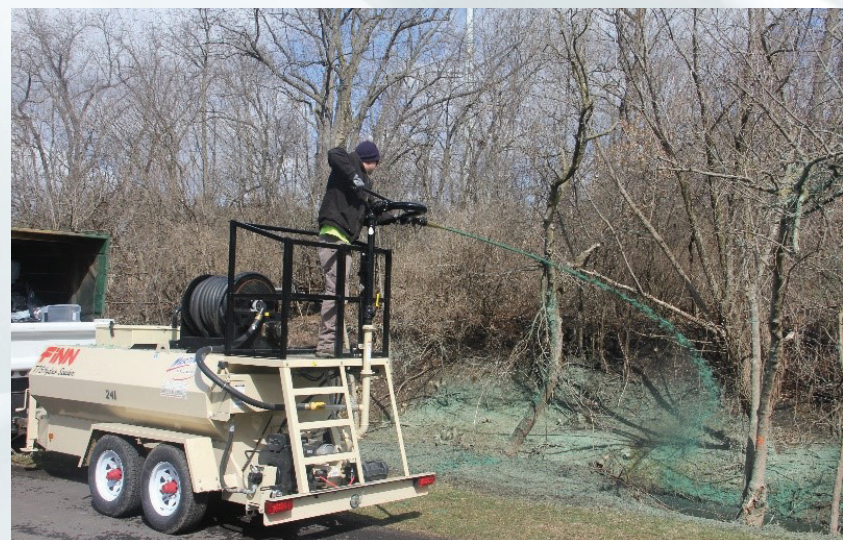
FIGURE 6 - HYDROSEEDING NATIVE SEED AT 63RD STREET PARK

The third facet, native planting, would occur shortly after the clearing of the hazardous material. The goal of this phase would be to augment the native herbaceous and woody plants at the site, increasing the biodiversity and creating a healthier and more stable environment for both the plants and animals that use the site. Where accessible, staff would hydroseed (**Figure 6**) a native seed mix suitable to the conditions of the site. This seed mix would contain a variety of species that would be adaptable to both sun and shade. The seed mix would be similar to the one used at Ide's

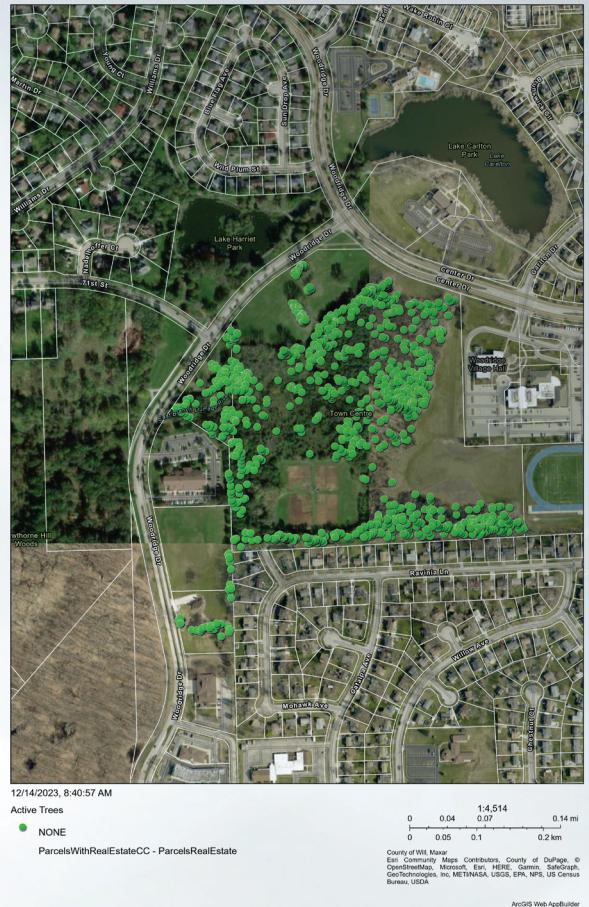
FIGURE 8 - TREES REMAINING AFTER ALL PROPOSED REMOVALS

Phase 2 of the park development project, proposes to remove an estimated 273 trees from the site, this number does include 48 trees that would be removed as part of the natural area improvement project including condition 5 (dead) and non-native trees. A total of 14 non-native trees and 34 hazardous trees would be removed in accordance to the natural area improvement recommendations laid out in this plan. Trees removed as part of the development of the site will be replaced in accordance with the Village of Woodridge’s tree preservation and replacement ordinance, which would require an estimated 113 trees (2.5” caliper) to be planted. **Figure 8** shows the locations of the trees that will remain after both the natural area improvements and proposed park site development occur. It should be noted that the District also plans on installing numerous smaller trees to improve the quality of the natural areas.
